CALIFORNIA DIVISION OF MINES AND GEOLOGY
FAULT EVALUATION REPORT FER-179

The San Jacinto Fault Zone (The Claremont, Casa Loma,
and Related Faults) in the Lakeview and El Casco
Quadrangles, Riverside County, California

James E. Kahle

June 18, 1987

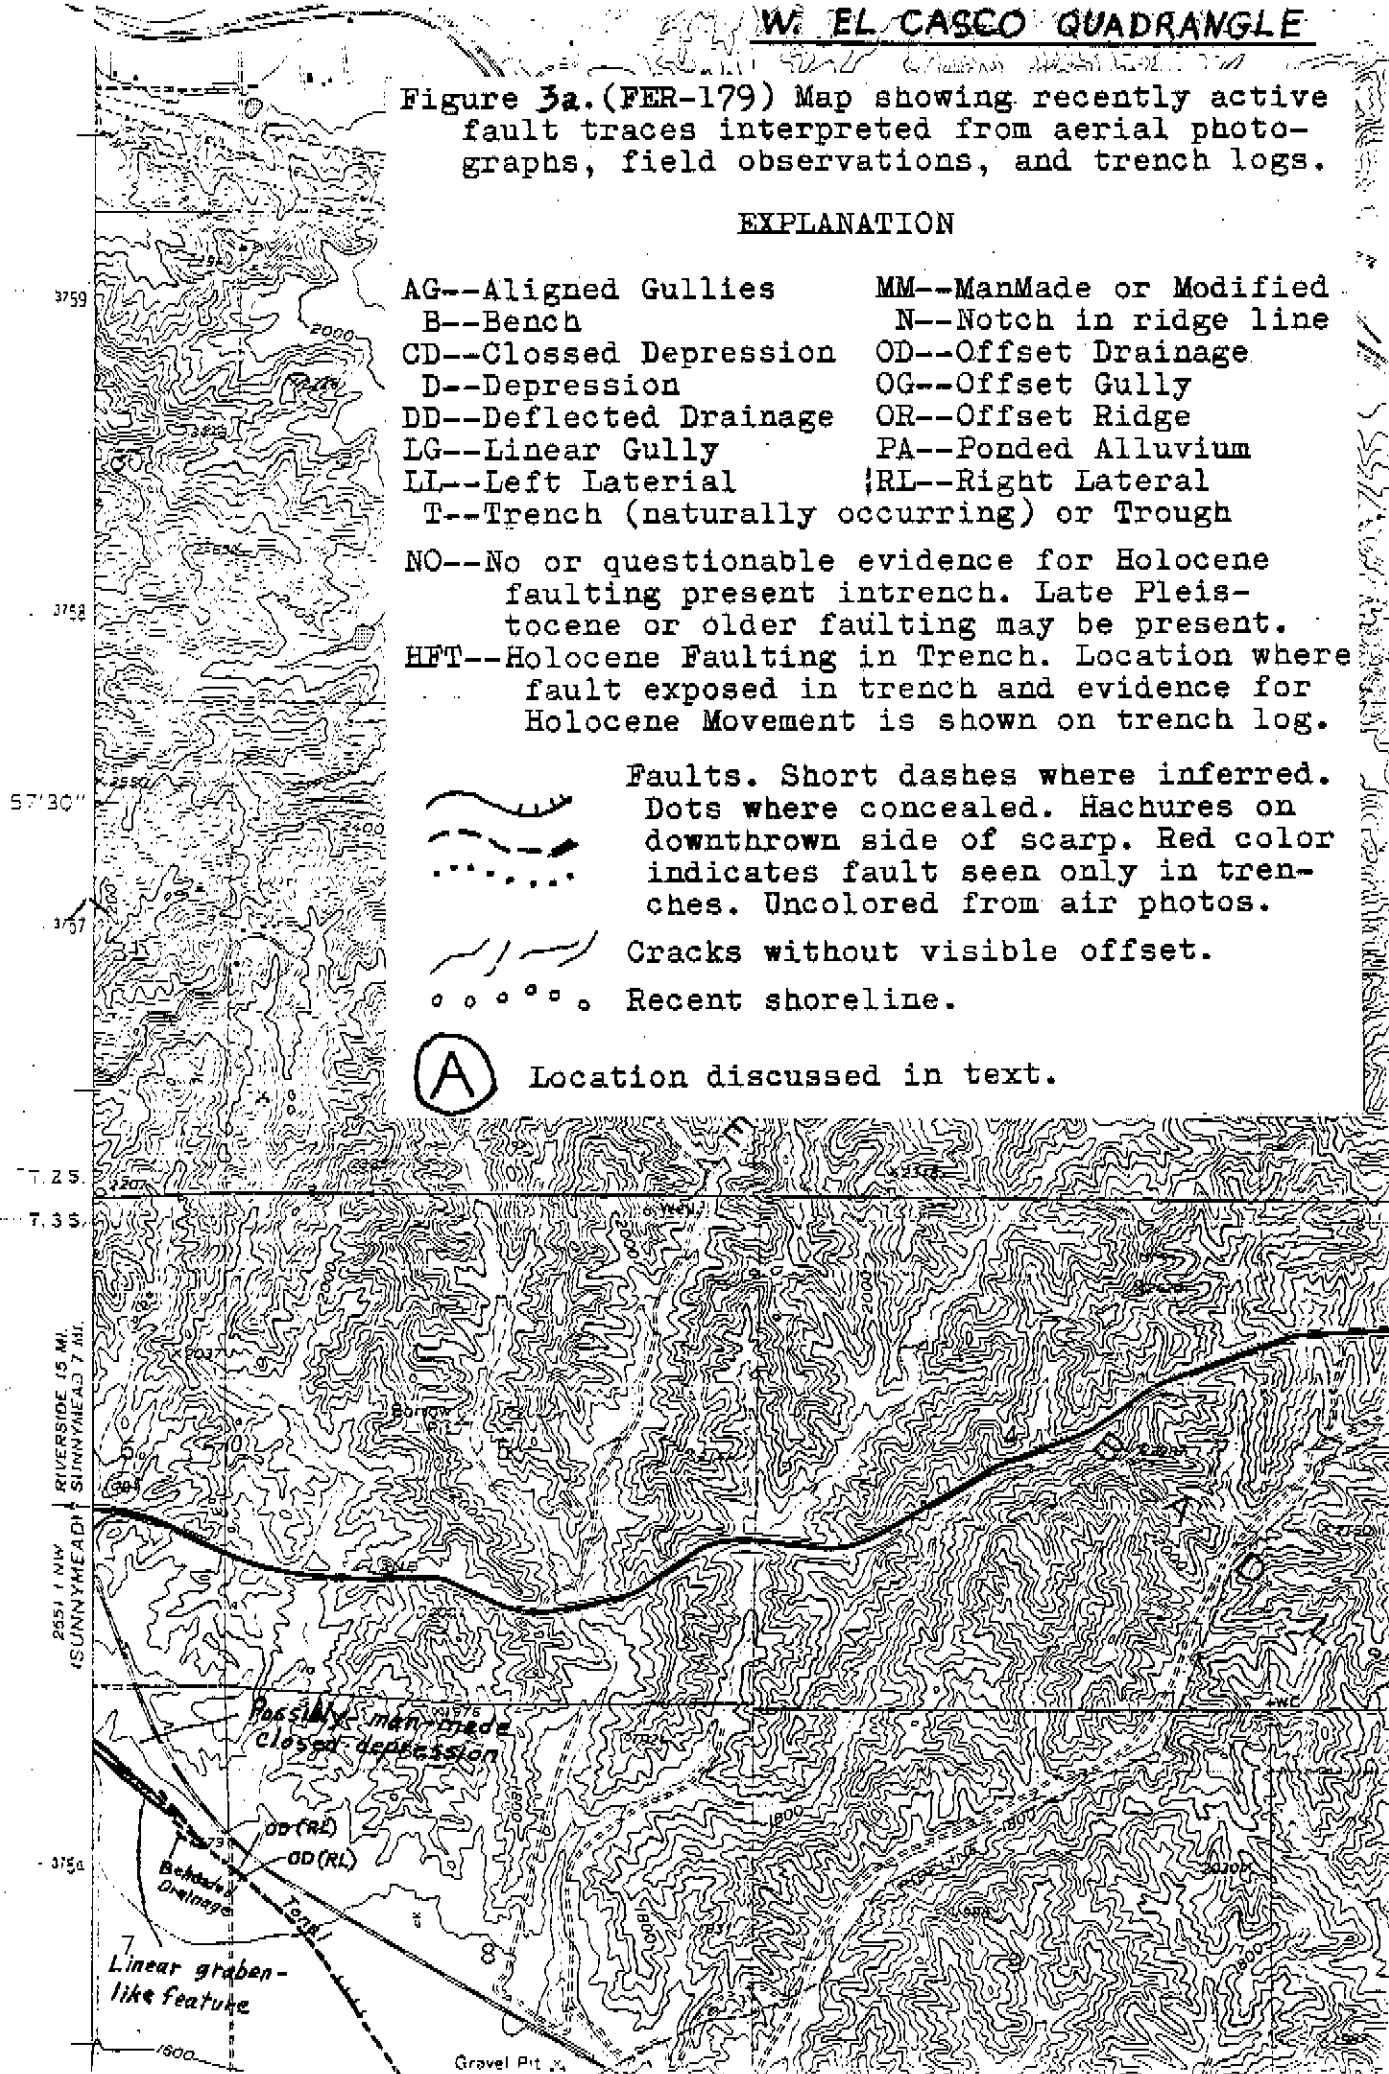
Figure 3a. (FER-179) Map showing recently active fault traces interpreted from aerial photographs, field observations, and trench logs.
